**Asbestos and Lead-based Paint Assessment Report
Colleton County Recreation Center
280 Recreation Lane
Walterboro, South Carolina
S&ME Project No. 4213-17-116**

Reference: **Limited Asbestos and Lead-Based Paint Assessment Report
Colleton County Recreation Center**
280 Recreation Lane
Walterboro, South Carolina
S&ME Project No. 4213-17-116

An asbestos and lead-based paint assessment was conducted on April 21, 2017 and May 5, 2017 of the Colleton County Recreation Center located at 280 Recreation Lane in Walterboro, South Carolina, limited to interior and exterior areas of the facility, excluding roofing materials. The purpose of the assessment was to identify the presence of asbestos containing materials (ACMs) and lead-based paint associated with the interior and exterior of the referenced structure, excluding roofing materials, to support renovation activities. The assessment also complies with federal, state, and local asbestos requirements regarding identification of asbestos containing building materials that may be disturbed due to renovation or demolition.

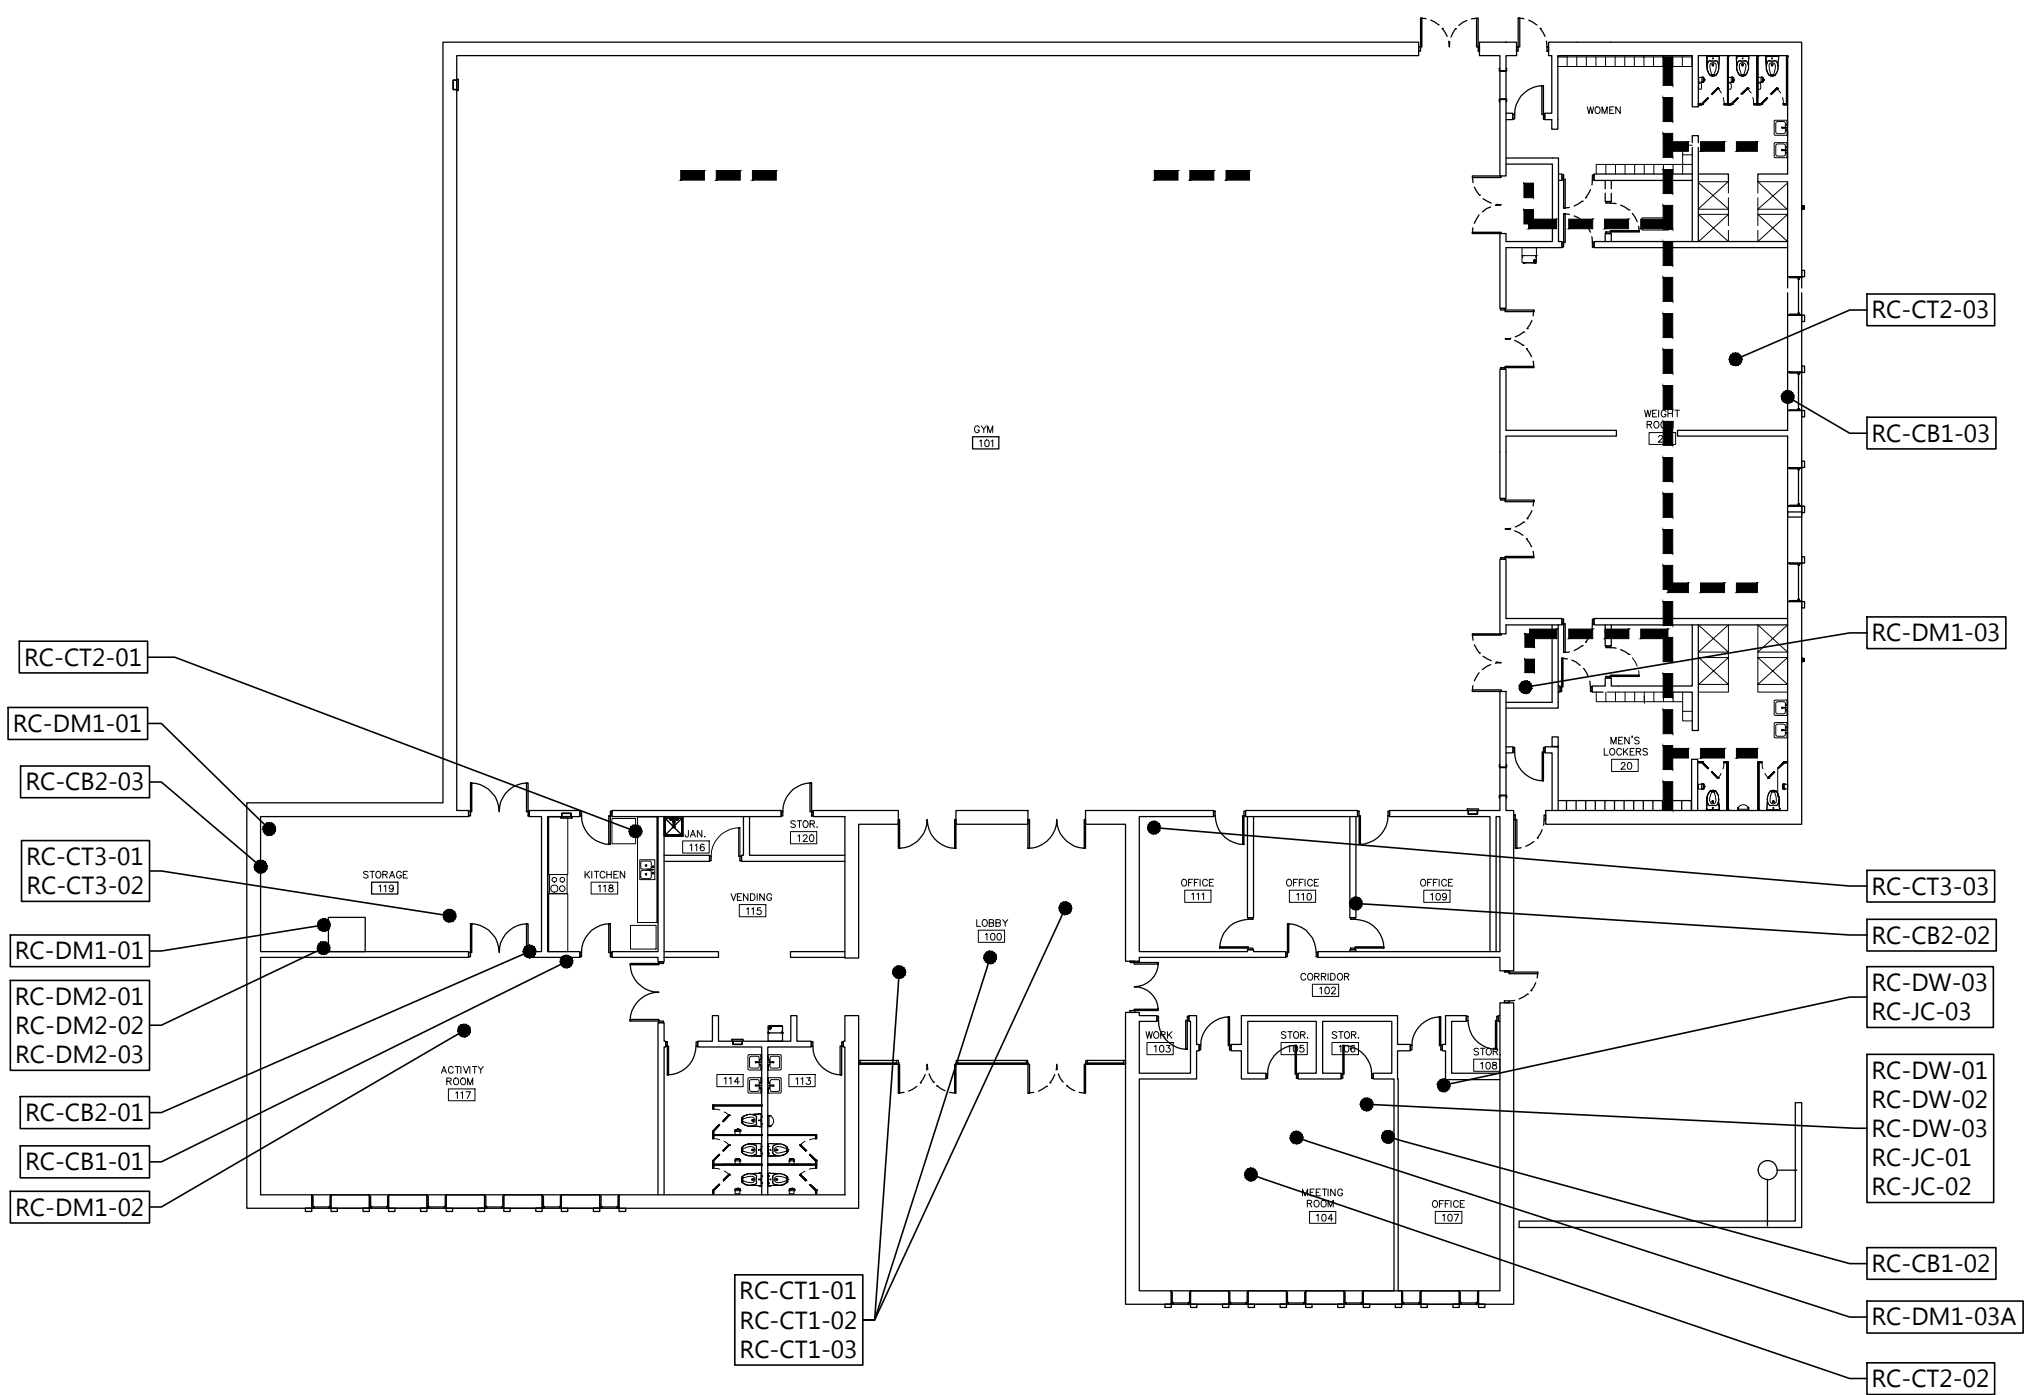
LIMITED ASBESTOS & LEAD-BASED PAINT ASSESSMENT		
COLLETON COUNTY RECREATION CENTER		
280 RECREATION LANE WALTERBORO, SOUTH CAROLINA		
SCALE: AS SHOWN	DRAWN BY: LAJ	APPROVED BY: TWR
PROJECT NO. 4213-17-116	DATE: 5-09-2017	FIGURE NO. 1

Material	HA	Location	Asbestos Type	Percent	Condition	Potential for Disturbance	*Approx. Quantity
Mastic (tan) associated with ductwork	DM1 (tan)	See Fig. 1	Chrysotile	9.1	G, NF	PD	850 SF

The identified asbestos containing mastic is classified as a Category I non-friable ACM, in good condition, with a potential for disturbance. The remaining bulk samples collected did not exhibit the presence of asbestos. The Environmental Protection Agency (EPA) and the South Carolina Department of Health and Environmental Control (SCDHEC) defines a material an ACM if an asbestos content greater than one percent (>1%) is detected in a representative sample.

▬ MASTIC (TAN) ASSOCIATED WITH DUCTWORK -APPROXIMATELY 850 SQUARE FEET

NOTES: NO PAINTED SURFACES MEETING THE SCDHEC DISPOSAL LIMIT OF 0.7 mg/cm² WERE DETECTED.

If the planned renovation activities will disturb the identified ACM, we recommend proper removal and disposal of the ACM, by a SCDHEC licensed asbestos abatement contractor, prior to any destructive activities to the ACM, as required by SCDHEC and EPA. If additional suspect ACMs not addressed in this report are discovered during the planned renovation activities, bulk samples must be collected by a SCDHEC licensed inspector and analyzed for asbestos content prior to disturbance or disposal of the suspect materials.
