**BID: CPST-08  
DEMOLITION AND DISPOSAL OF FACILITY LOCATION  
115 BENSON STREET**

**Addendum #1  
dated 1-25-2017**

**Asbestos and Lead-based Paint Assessment Report (revised)**  
**115 Benson Street**  
**Walterboro, South Carolina**  
**S&ME Project No. 4213-16-110**

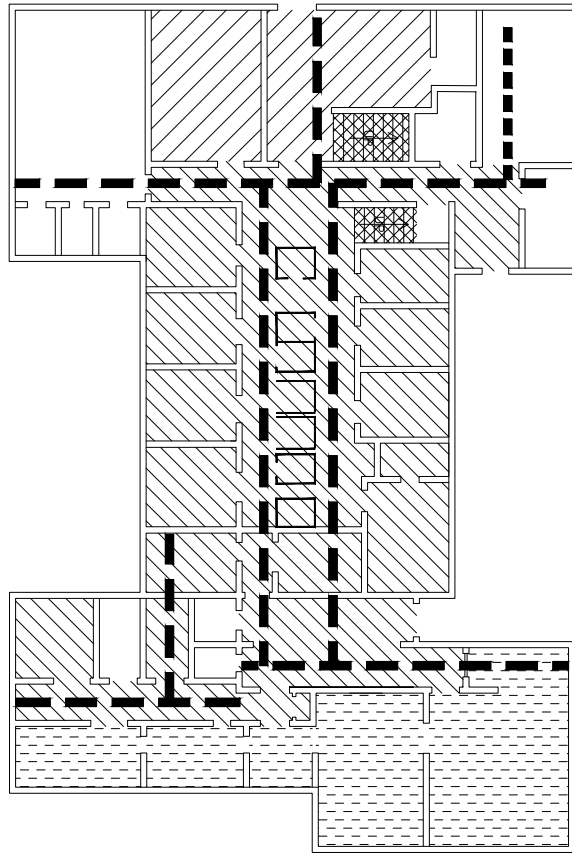
SCALE:	NTS	DRAWN BY:	LAJ
PROJECT NO:	4213-16-110	APPROVED BY:	DG
DATE:	6-07-2016	FIGURE NO.	4

- WOOD DOORS AND CASINGS LOCATED THROUGHOUT - INTACT CONDITION
- PLASTER WALLS LOCATED THROUGHOUT - INTACT CONDITION

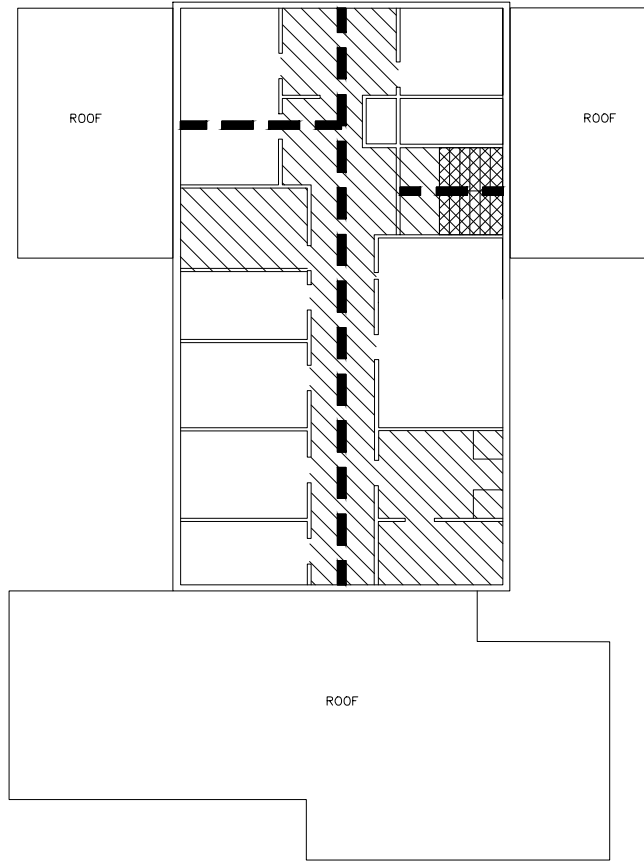
- WOOD DOORS AND CASINGS LOCATED THROUGHOUT - INTACT CONDITION
- PLASTER WALLS LOCATED THROUGHOUT - INTACT CONDITION
