COMPREHENSIVE ASBESTOS SURVEY

COLLETON COUNTY SHERIFF'S OFFICE
119 BENSON STREET
WALTERBORO, SOUTH CAROLINA

EXECUTIVE SUMMARY

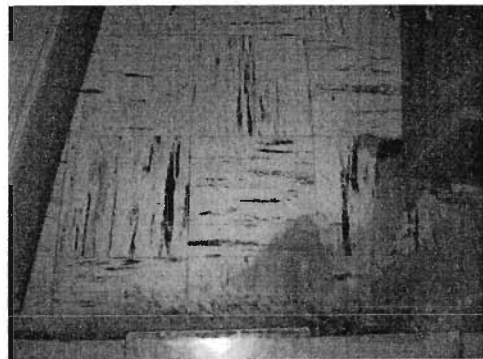
HOMOGENEOUS AREAS # 08, 09
9" VINYL FLOOR TILE (GRAY)
BOTTOM LAYER/ADHESIVE

Asbestos fibers were identified in the 9" Vinyl Floor (gray) Bottom Layer (22000 square feet) and the Built Up Roofing (11500 square feet). These materials are in good condition and are considered Category I – Non-Friable Asbestos.

The identified asbestos containing building materials (ACBM's) to include the item(s) listed above. All removal work of this material should be performed by a properly trained and licensed abatement contractor prior to the planned renovation work to avoid potential exposure and/or contamination.
