COMPREHENSIVE ASBESTOS SURVEY

COLLETON COUNTY SHERIFF'S OFFICE
119 BENSON STREET
WALTERBORO, SC

Trident Environmental Services, Inc.

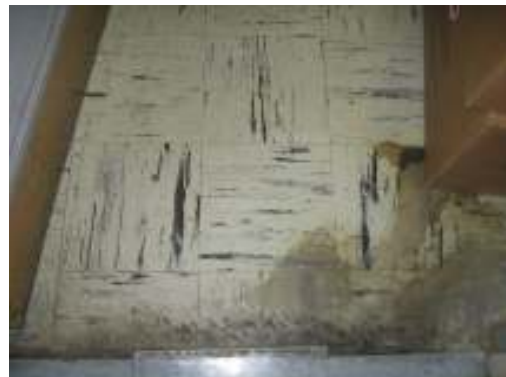
Asbestos fibers were identified in the Gray 9" Floor Tile. Approximately 10,00 square feet is present and in good condition. This material is considered Category I – Non Friable asbestos.

HOMOGENEOUS AREAS # 08, 09
9" VINYL FLOOR TILE (GRAY)
BOTTOM LAYER/ADHESIVE

The identified asbestos containing building materials (ACBM's) to include the item(s) listed above. All removal work of this material should be performed by a properly trained and licensed abatement contractor prior to the planned renovation work to avoid potential exposure and/or contamination.

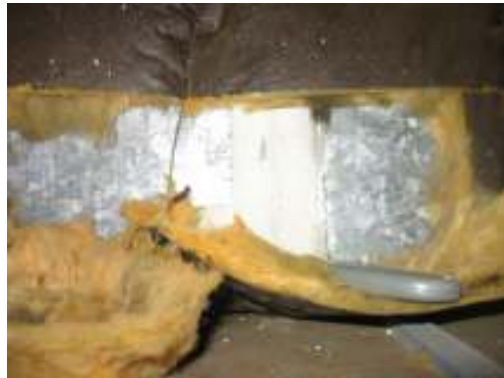
Asbestos fibers were identified in the HVAC Duct Tape. Approximately 3,100 square feet is present and in damaged condition. This material is considered RACM – Friable Asbestos.

HOMOGENEOUS AREA #14
HVAC DUCT TAPE (WHITE)
